# FINAL WATTS BRANCH WATERSHED ASSESSMENT

September 2015

City of Rockville, Maryland  
Department of Public Works

BayLand Consultants & Designers, Inc.

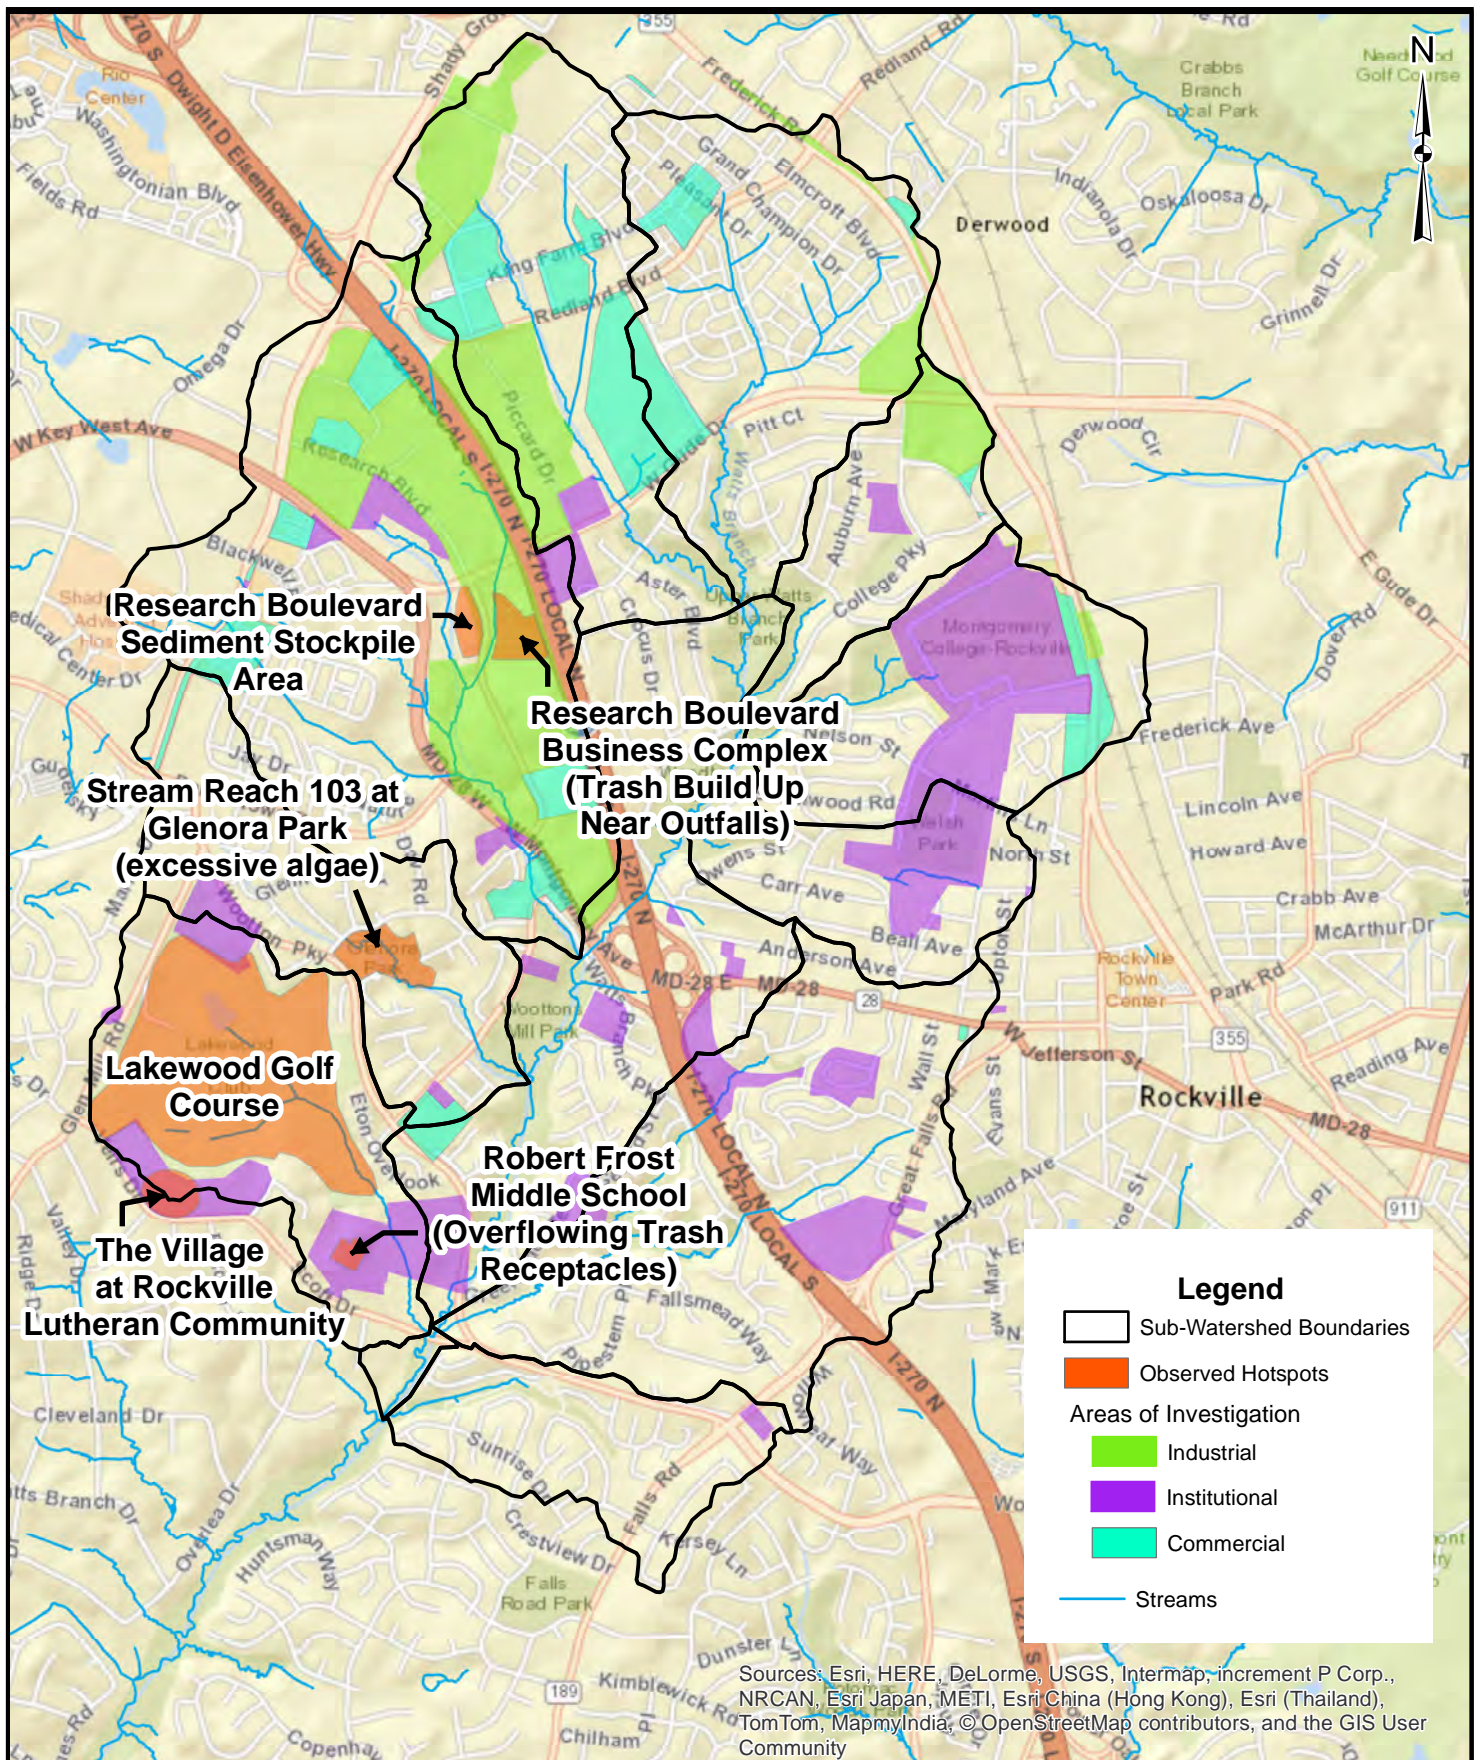
**FIGURE 12  
POTENTIAL  
POLLUTION SOURCES**

Figure 12 shows the hotspot locations identified in the City's portion of the Watts Branch watershed. Table 3.2 lists the locations of hotspots in the watershed and identifies the problems observed at these locations. At these locations, observations included: vehicle operations, outdoor storage practices, waste management, building conditions, landscaping maintenance, storm drain/stormwater infrastructure, and any other observable practice which may indicate a pollution source. It is important to note that the observations noted are based upon a single day's

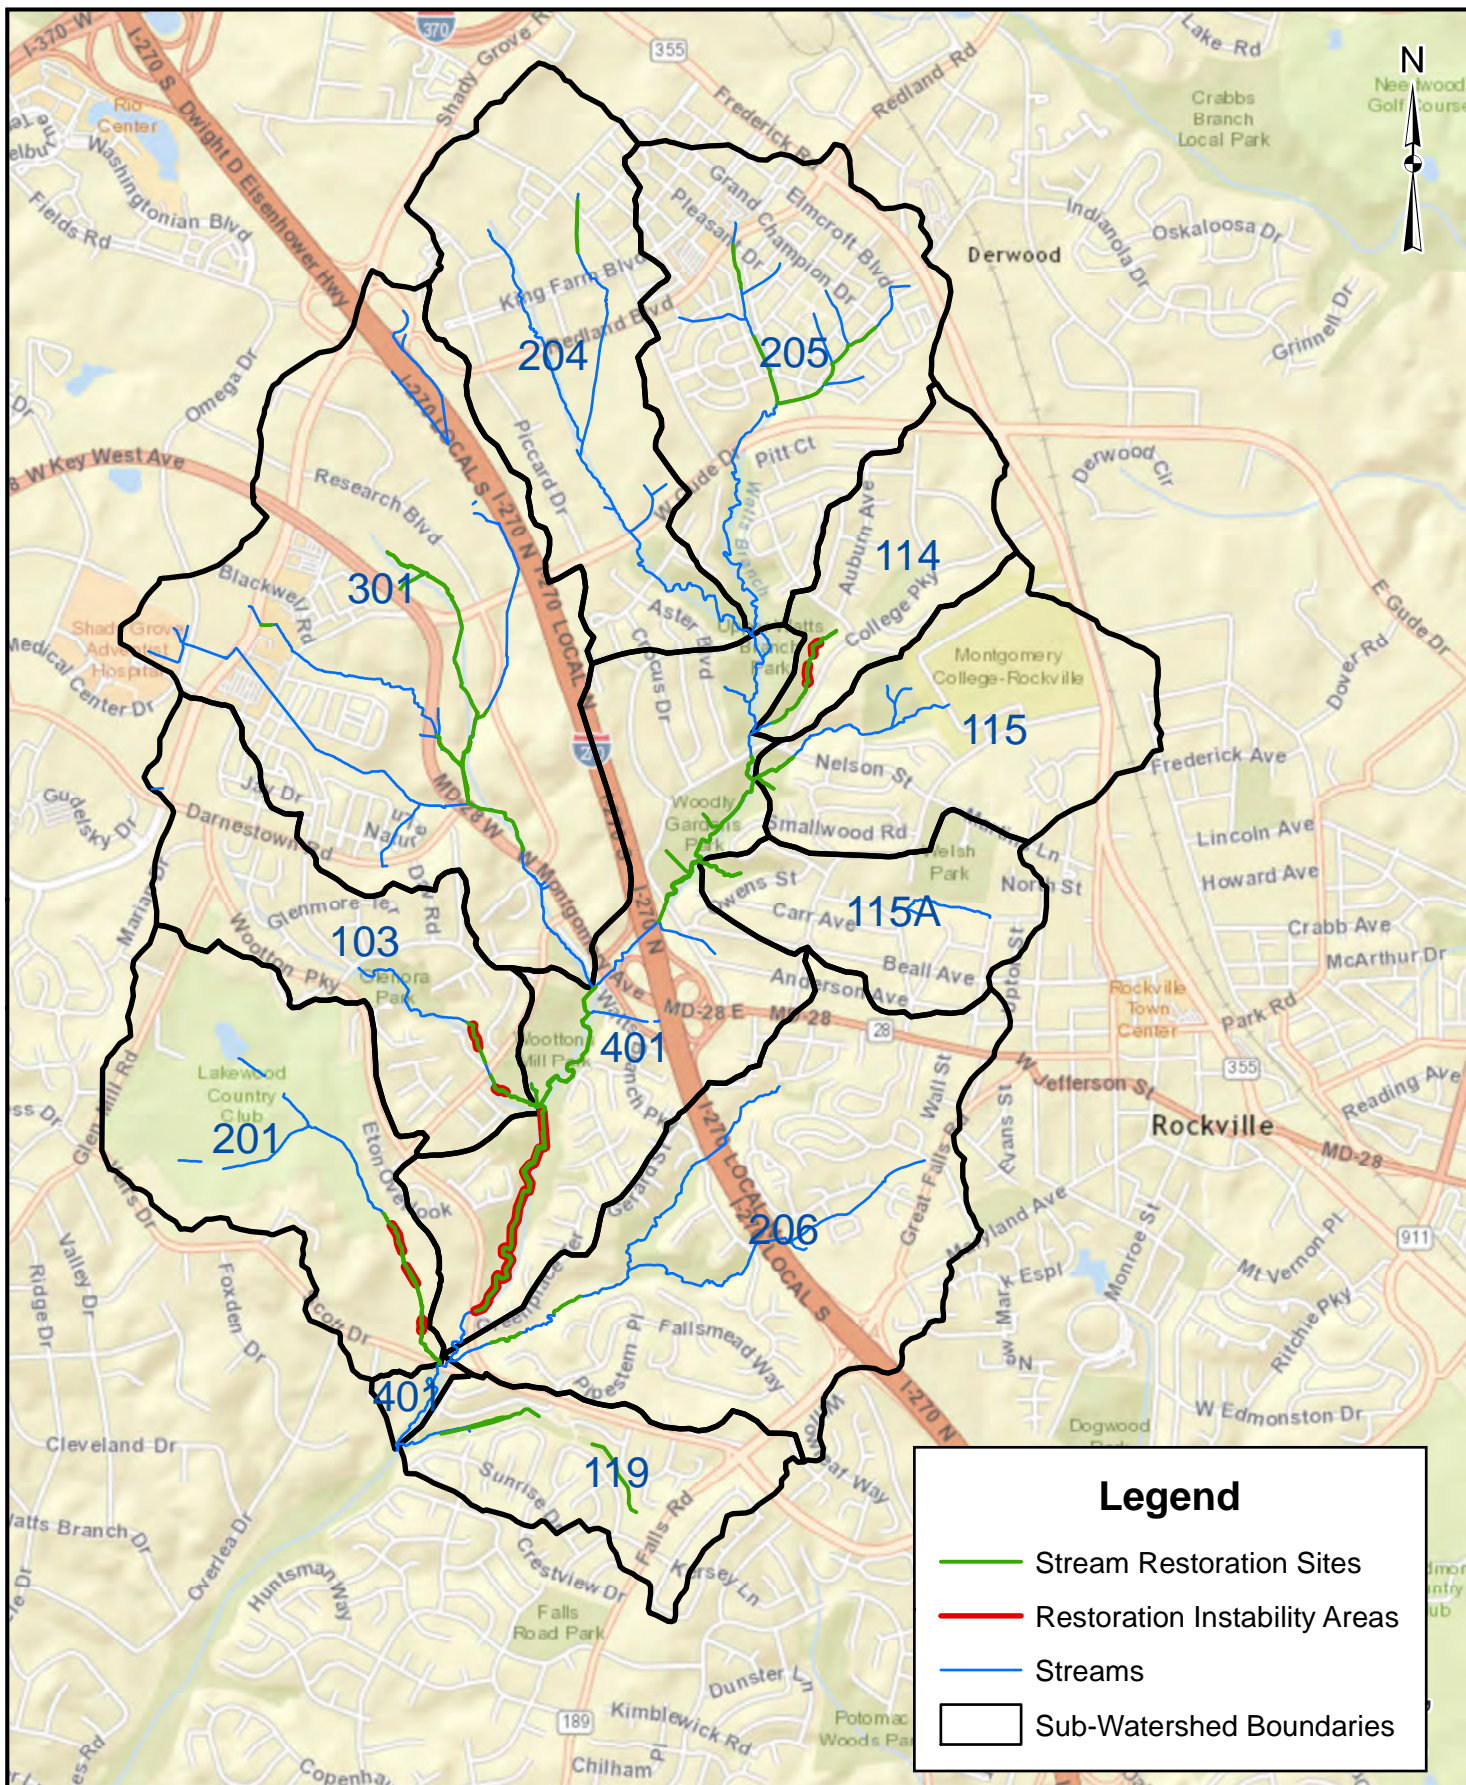
**FIGURE 14  
STREAM RESTORATION  
SITES**

Between 2001 to 2014, the City constructed 3.25 miles of stream restoration/stabilization measures in Watts Branch (Figure 14). Some projects were very successful at reducing bank erosion and in-stream sediment loads, as seen in portions of Reaches 107, 115, 115A, and 302. The stream restoration projects in reaches 103, 114, 201, and 401 have some localized areas of failure. Three of the projects in reaches 103, 201, and 401 were completed in the early 2000's. Only one project within Reach 114 was completed recently in 2008. The areas of failure which were visually observed included:

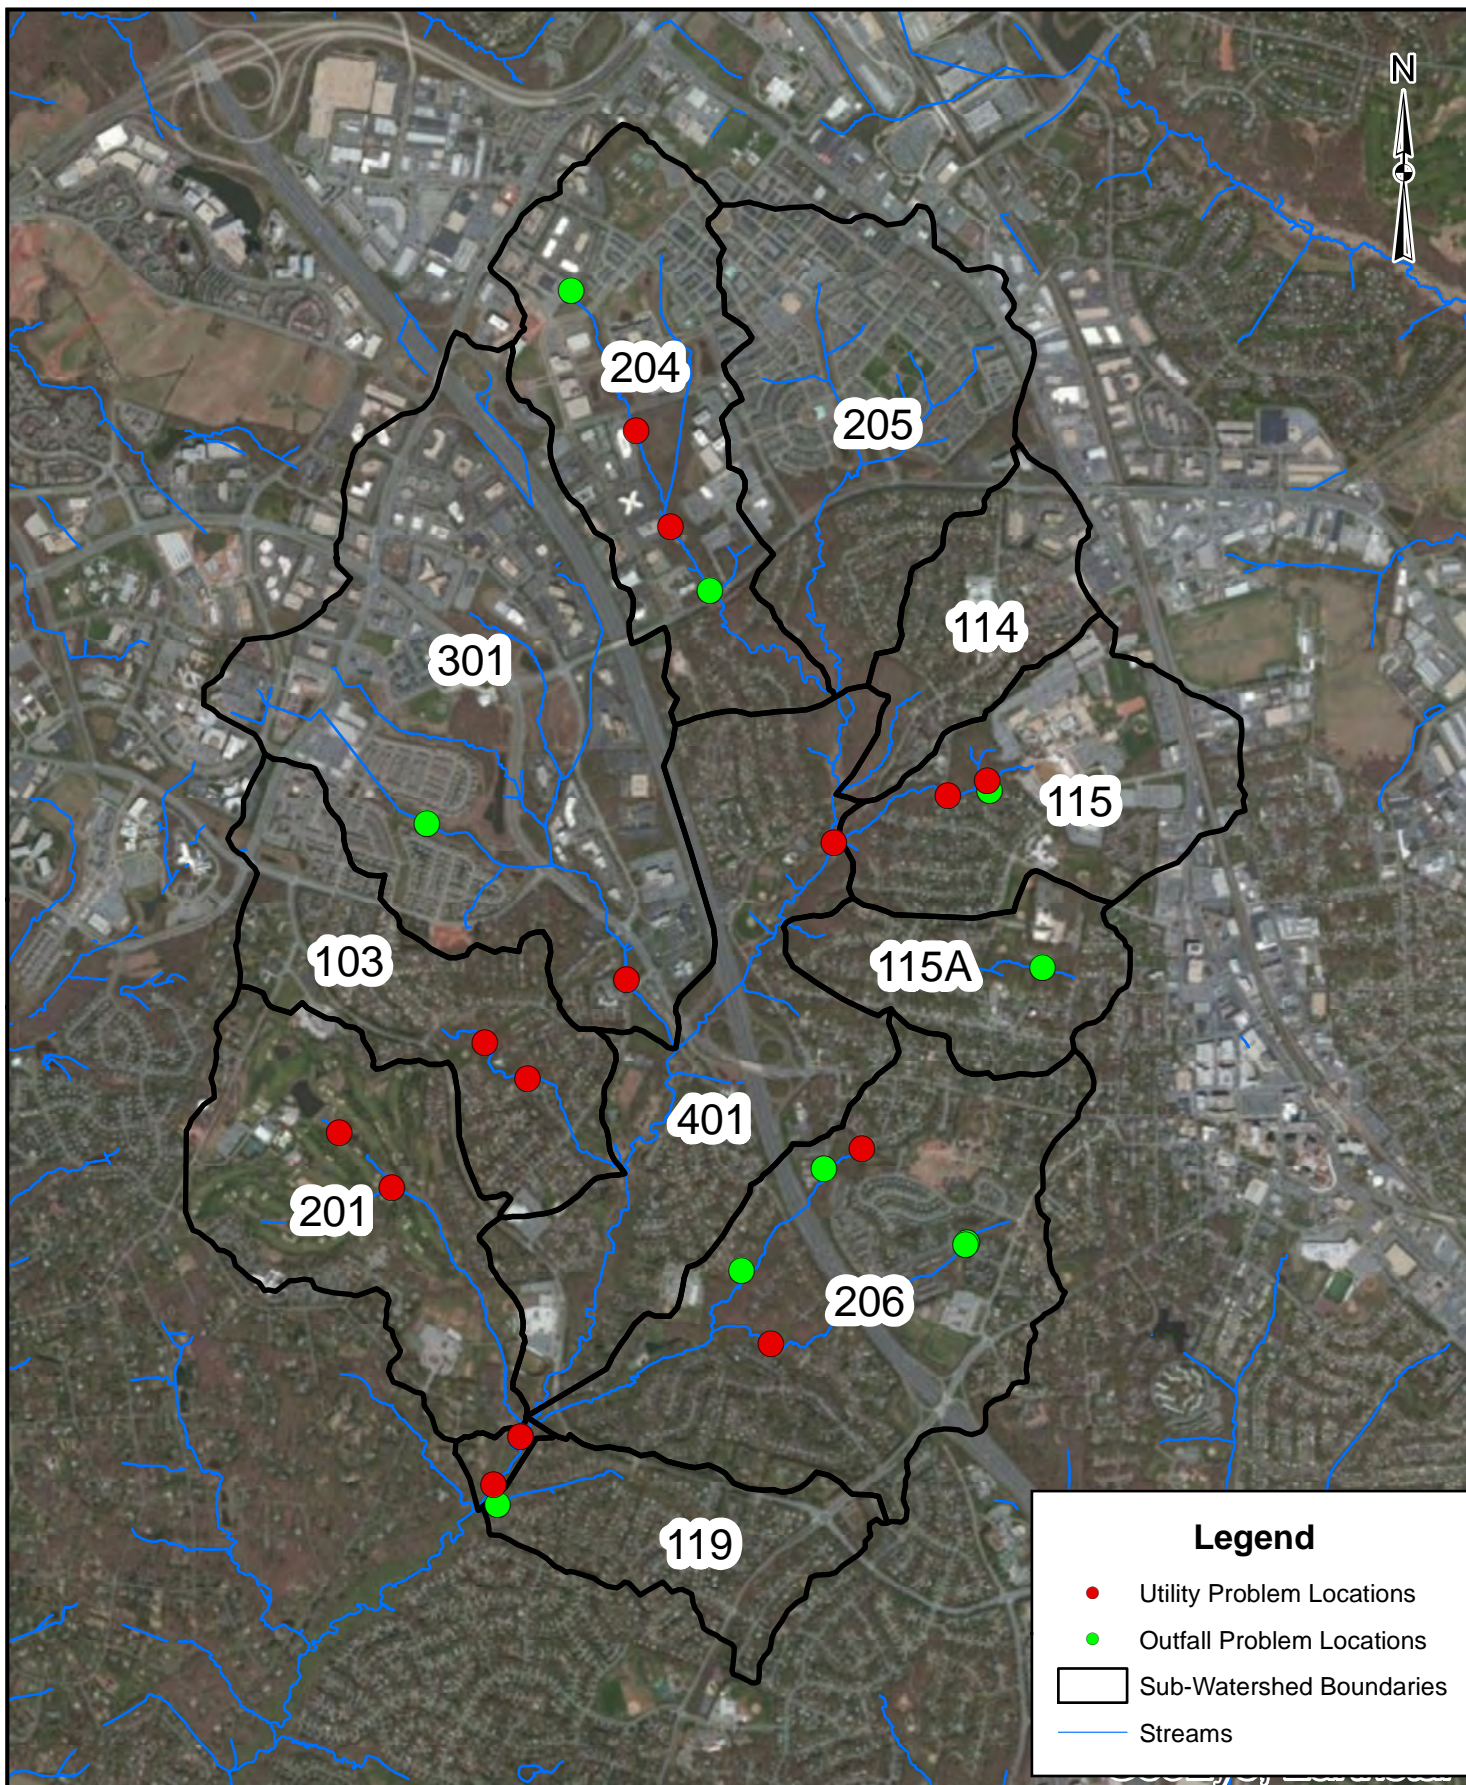
Table 3.3 Exposed Sanitary Manhole and Pipes					
Site ID	Subwatershed	Reach ID	Type	Notes	Ownership
UT 103-1	103	103	Sewer manhole and pipe	Concrete is deteriorating around pipe. Manhole is 7' high.	City of Rockville
UT 109-1	204	109	Sewer manhole	Exposed manhole is 5' high and minor deterioration of concrete is exposing bricks.	City of Rockville
UT 115-1	115	115	Sewer manhole and pipe	Concrete encasement has deteriorated and underneath the exposed pipe is undermined. Manhole is exposed on the right bank.	City of Rockville
UT 115-2	115	115	Sewer pipe	Pipe is not concrete encased.	City of Rockville
UT 117-1	206	117	Sewer pipe	Concrete encasement is mostly gone and there is undermining.	City of Rockville
UT 118-1	206	118	Sewer pipe	Pipe is being undermined and the concrete is deteriorating.	City of Rockville
UT 204-1	204	204	Sewer manhole	Manhole is exposed along left bank and is 3.5' high.	City of Rockville

UT 401-1	401	401	Abandoned sewer pipe	Appears to be inactive; pipes are exposed in three locations with lengths of 15', 10' and 93'. They are not aligned with existing manholes.	Unknown
UT 401-2	401	401	Abandoned sewer pipe	Two exposed pipes running parallel to each other. It is unclear if the pipes are active and flow is going under the pipes.	Unknown
